# Case History on Defined Sump Floating Cover System, MWD Southern California, Skinner Water Treatment Plant

Brian W. Fraser, MBA, Layfield Group Limited, Edmonton, Alberta, Canada  
Mike P. Neal, Layfield Environmental Systems Inc., San Diego, California, USA  
Hans J. Vandenberg, P.E., Metropolitan Water District of Southern California, USA

**THIS PAPER WAS ORIGINALLY PRESENTED AT THE 2011 GEOSYNTHETICS CONFERENCE | DALLAS, TX, USA**

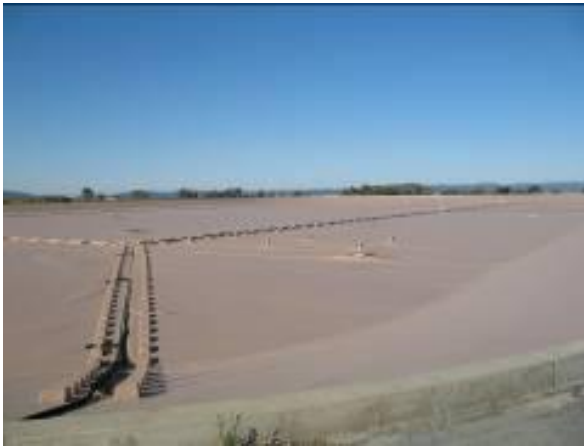
*Figure 1: Overview of Floating Cover*

of this project. The scope of work included decommissioning the older geomembrane floating cover system and supplying and installing a new 65,000 m<sup>2</sup> (700,000 ft<sup>2</sup>) floating cover system including various electrical, mechanical and concrete restoration work. As the asphalt base was in poor condition a special 30.5 metre (100 foot) reinforced chafer strip was required directly underneath the floating cover located on the slope. The chafer strip was designed to prevent abrasion of the primary floating cover material and was mechanically attached around the full perimeter to the main concrete berm anchorage system. The decommissioning of the old liner system and installation of the new liner system included approximately 1,036.3 metre (3,400 lineal feet) of mechanical attachment to the concrete anchorage system in accordance with the Standard Guide for Mechanical Attachment of Geomembrane to Penetrations or Structures (ASTM D6497). The existing geomembrane cover system was over 20 years old and showing some signs of material fatigue and damage. The owner had growing concerns related to safety issues as the cover system required both planned and unplanned maintenance requiring personnel to work on top of the cover while the system was in operation. This was one of the main factors in the owners' decision to replace the existing floating cover system.

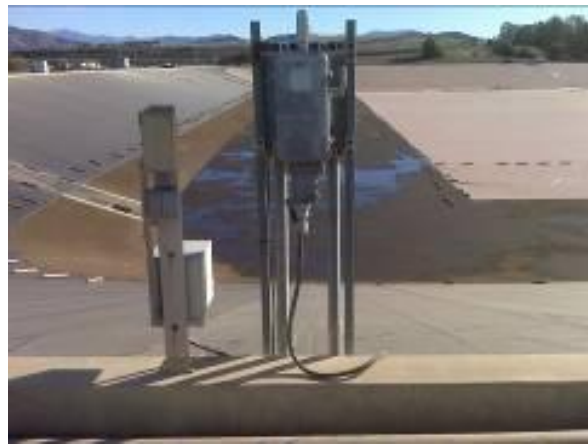
*Figure 2: Chafer Strip & CSPE Cover*

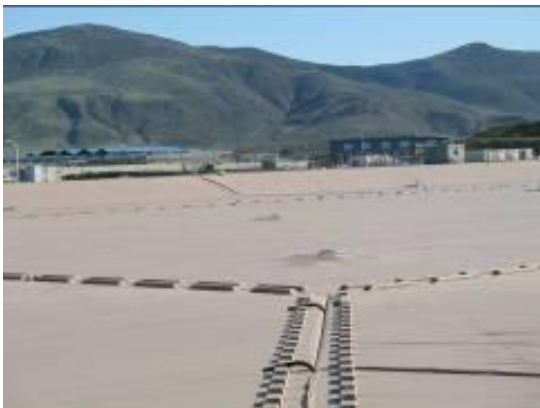
*Figure 3: Defined Sump Design*

The floating cover system incorporated a defined sump design closely following the AWWA California-Nevada Section Reservoir Floating Cover Guidelines. Hilt Consulting Group, Inc. from Chino, California provided the design of the floating cover system. Further to the AWWA CA/NV guidelines the owner requested additional design features including additional secondary rainwater removal suction hoses. The primary rainwater removal pumps also required further design precautions to prevent the pumps from pumping dry. These included a flow meter at the top of the slope with input being fed back in the control panel. The owner also required a special tan top ply color for the floating cover material which better matched existing site requirements.

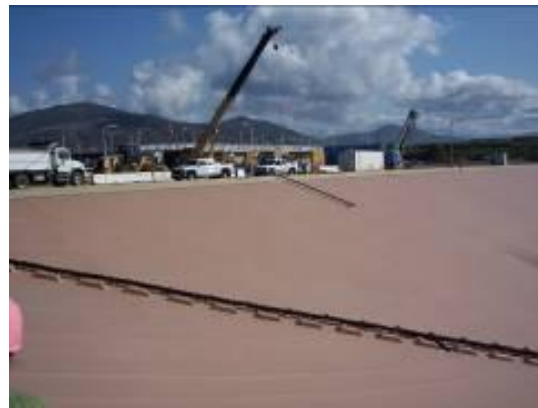
*Figure 4: Installation of Pipe System*

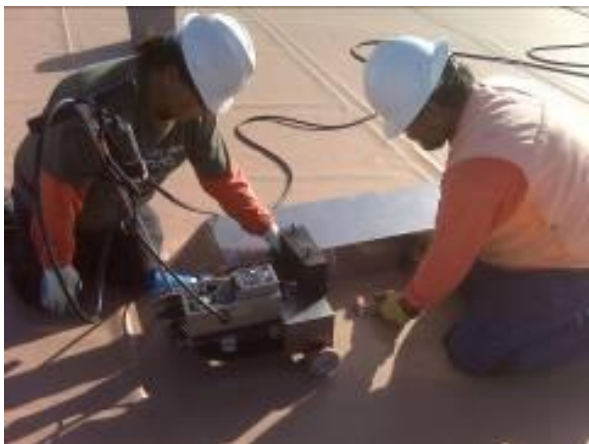
Figure 5: Fabrication of Sump Floats

The project faced a number of operational, design and construction challenges. One of the main operational challenges was with the construction schedule. As this was the water districts' single finished water reservoir with 130.4 hectares (326-acre feet) of capacity servicing the Riverside and San Diego Counties it was critical that project was completed during non-peak demand season. To address the tight time constraints the floating cover material was prefabricated in the contractor's geomembrane fabrication plant in El Cajon, California facility prior to the water reservoir being taken out of service. The prefabrication technique included producing 10.36 meter (34') wide fabricated panels without any accordion folds in the panels as folding of any kind of the main floating cover material was not allowed in accordance with the project specification. This prefabrication requirement reduced workmanship issues commonly associated with field wrinkles and enhanced field panel deployment, welding times and overall quality. A special 75 mm (3") wide wedge was used for all factory and field welding of the geomembrane. This wider than normal 75 mm (3") wedge welding technique provided increased tensile strengths in the seam and a fully welded top and bottom seam with no loose edges. The wedge welding further reduced the need for chemical solvent welding which enhanced installation speed and quality. Both hot air welding and a specific CSPE adhesive were used in the field to fabricate pipe boots and custom fittings for hatches, walkways and various other cover appurtenances. All field or factory cut edges which had an exposed fabric scrim were flood coated with the adhesive to fully encapsulate the scrim. At regular scheduled intervals throughout the workday, peel and shear testing was performed on all factory and field welds. To confirm overall welded seam integrity, all factory and field seams were further tested and then air lance tested following the guidelines of Standard Practice for Non-destructive Testing (NDT) for Determining the Integrity of Seams Used in Joining Flexible Polymeric Sheet Geomembranes (ASTM D4437-08). The total cover was further inspected by inflating in sequence specific sections for visual inspections of holes and defects.

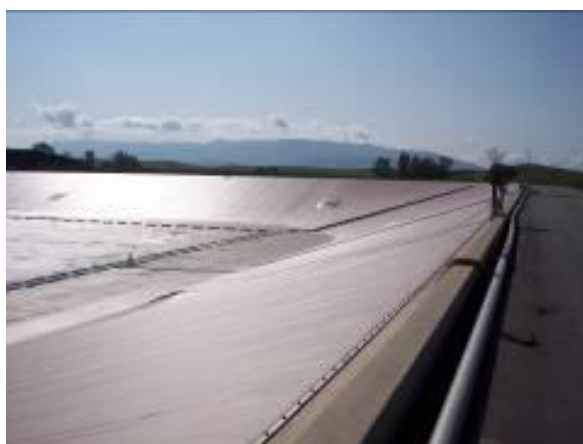
Figure 6: Mechanical Anchorage Detail

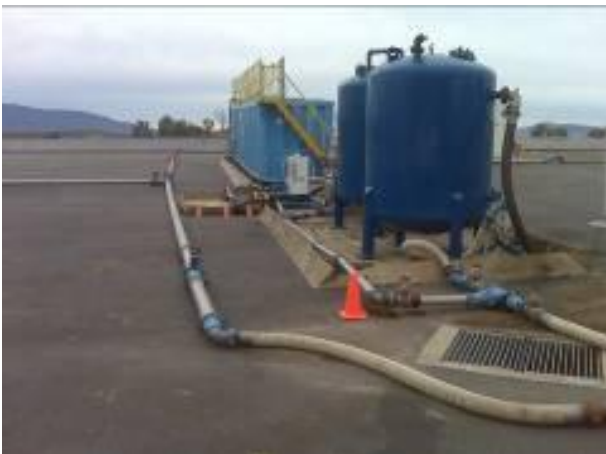
Figure 7: Water Treatment Plant

A second key project challenge was the requirement to capture, treat and discharge all water that was collected from the construction site. The water sources included normal rainwater and flush water used during the start up and testing procedures. This challenge required the design, construction and operation of a temporary water treatment facility as the Regional Water Quality Board had set strict discharge limits on the water released from the site. This process required a peak design capacity of 1,325 liters (350 gallons) per minute. The equipment included submersible dewatering pumps, piping systems, 30,200-liter (8,000 gallon) Weir holding tank, a bag filter system for sediment removal and two 2,268 Kg (5,000 lb) carbon vessels to remove any residual volatile organic compounds. Random and scheduled independent third-party testing was conducted on the effluent to ensure it was within the strict discharge limited. A final flow meter with totalizer function was installed in-line just upstream of the catch basin to record actual discharge flow rates and the total volume discharged over the construction period. The water treatment plant was designed to capture all nuisance chemicals, contaminants and sediment in rainwater as a result of construction. The general contractor's scope of work included the construction and decommissioning of the temporary water treatment plant. The water treatment plant was then decommissioned shortly after the facility was operational and final tests verified satisfactory discharge levels. During construction approximately 15.1 million liters (7.5 million gallons) of surface rainwater were treated and discharged through the temporary water treatment plant.

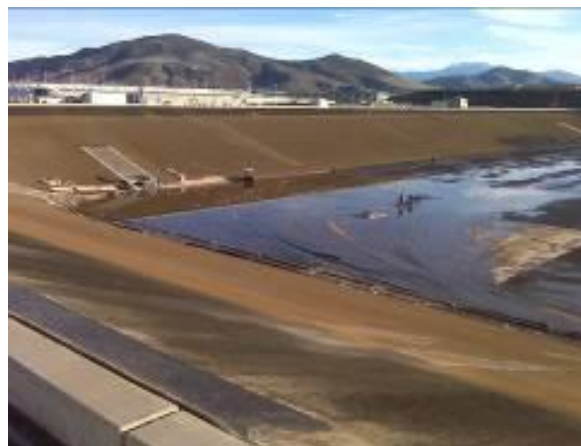
Figure 8: Water Infiltration & Dewatering requirements

A final and unexpected project challenge came from water infiltration problems as a result of leaks at the influent and effluent reservoir gates and unexpected heavy rains. Major water leakage at the pipe gates up to 1,335 litres (300 gallons) per minute required special dewatering strategies. These included the construction of portable coffer dams that allowed the potable water to be captured and accumulated prior to being pumped back into the main water districts treatment facility. Special back up pumps were also required. Water infiltration problems were further compounded by heavy rain storms as a result of an El Nino year caused construction delays and required major site dewatering strategies. The portable coffer dams were also used to separate all accumulations of rain water from the potable water leaking from the pipe gates. All accumulations of rain water had to be treated through the temporary water treatment plant. The combination of heavy rain events and the high volume of water leaking from the pipe gates created a number of challenges throughout the duration of the project.
